MAJOR ORIENTATION-ERROR ACCIDENTS IN REGULAR ARMY UH-1

AIRCRAFT DURING FISCAL YEAR 1967: ACCIDENT FACTORS

W. Carroll Hixson, Jorma I. Niven, and Emil Spezia

October 1970

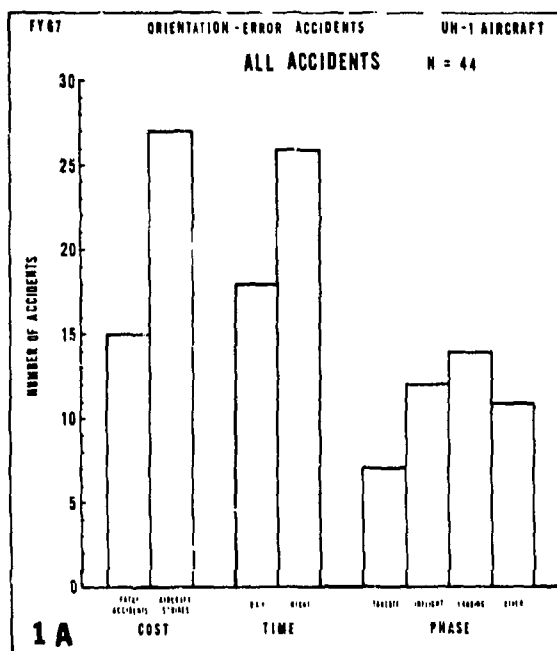
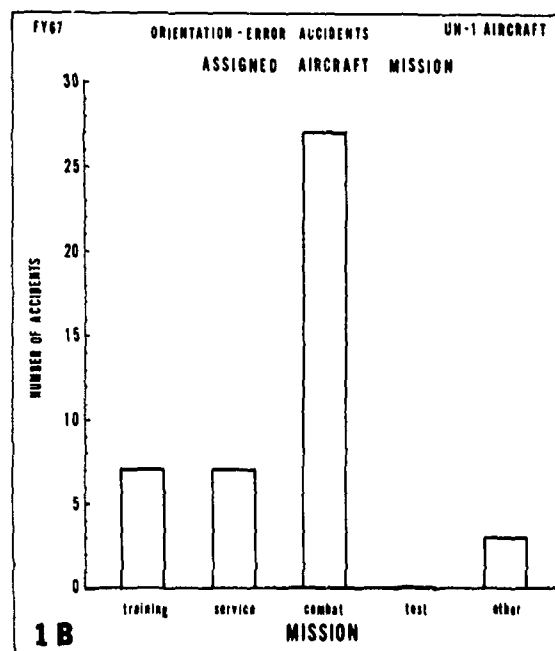
Figure 1

Before presenting the individual case-history data for these 44 accidents, a brief summary will be made of selected background information pertinent to the accidents as a whole. As indicated by the cost data in Figure 1A, the hazard of orientation-error accidents was considerable for that fiscal year. Some 34.1 percent of the accidents were fatal, while 61.4 resulted in a total loss of the aircraft. The time-of-day data show that the majority of the accidents (59.1 percent) occurred at night. In terms of the phase of flight in which the accident occurred, Figure 1A indicates that the greatest number of accidents took place while landing, the least during takeoff. It should be noted that the "other" phase classification used in this report denotes localized operations, such as reparking an aircraft, lifting a sling load, or moving an aircraft to a nearby refueling site. Though such operations may involve a takeoff, a short hovering flight, and a landing within the confines of a field, the takeoff classification is reserved solely for conventional outbounds or departures, the landing classification for inbounds, and the inflight classification for the intermediate phase.

The mission data presented in Figure 1B show that the majority (61.4 percent) of the accidents occurred on flights that had some form of combat-related mission assignment. This would be expected since 37 (84.1 percent) of the 44 accidents occurred in Vietnam. The reader is reminded that although a combat mission may have been assigned to the crew, the resulting mishap was an accident and not a loss attributable to direct enemy action.

Major orientation-error accidents occurring in Regular Army UH-1 aircraft during fiscal year 1967. Number of fatal accidents, number of aircraft strikes, time of day of the accidents, and the flight phase in which the accident occurred (A); and types of missions assigned to the accident aircraft (B).

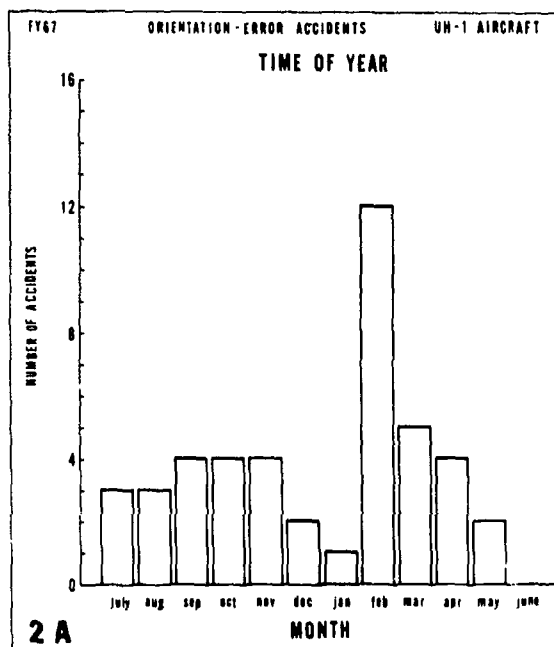
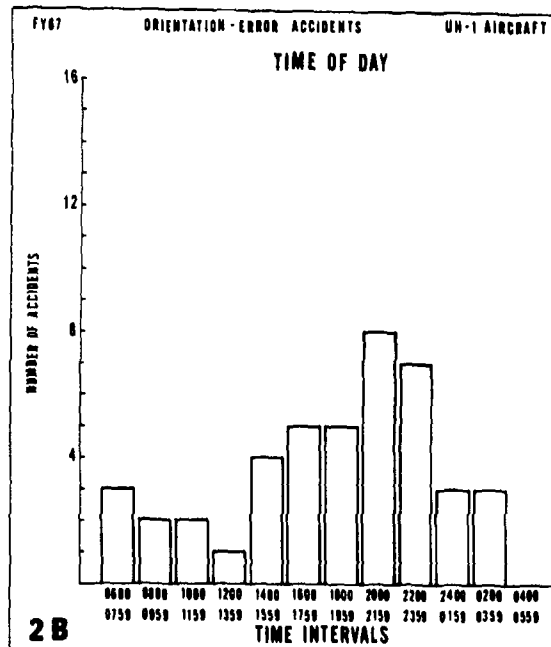
Figure 2

In Figure 2A a distribution is given of the number of accidents during each month of the fiscal year. Since the majority of the accidents occurred in Vietnam, the time-of-year incidence of accidents due to weather and dust peaked in that country's monsoon and dry seasons, respectively. Interpretation of these data beyond this point is restricted by

Number of orientation-error accidents as a function of the time of year (A) and the local time of day (B).

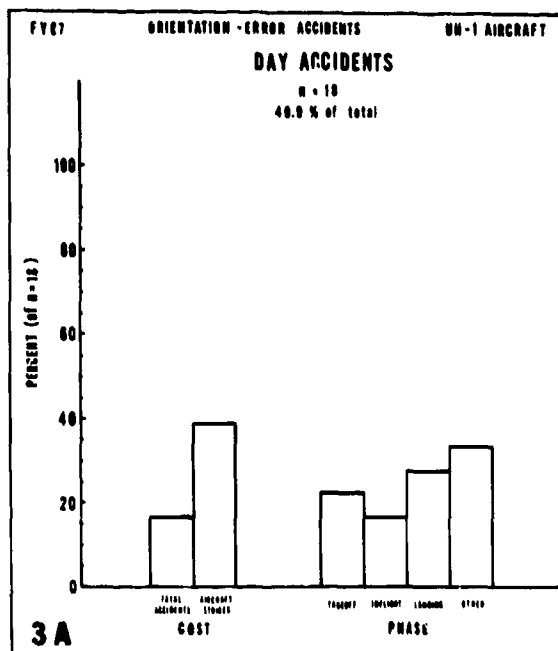
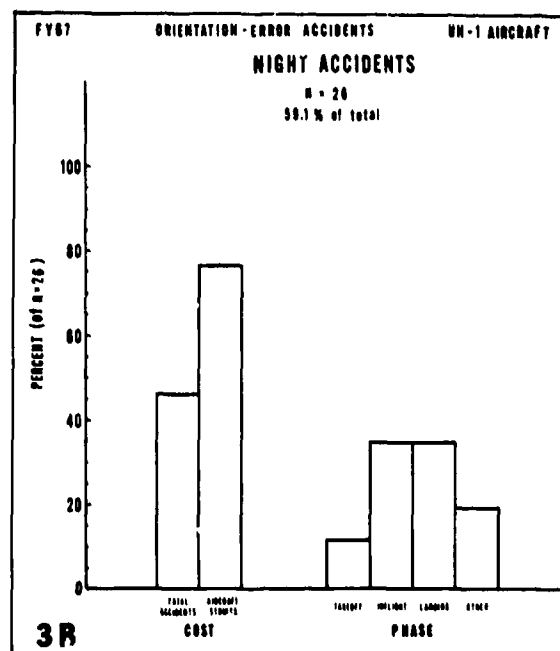
Figure 3

Additional data related to the time-of-day incidence of the accidents are presented in Figure 3. Statistics pertinent to the 18 accidents that occurred under daylight visibility conditions are plotted in Figure 3A. Similar data for the 26 night accidents are shown in Figure 3B. It is obvious that the cost of night accidents in terms of fatal accidents and aircraft strikes was considerably greater than the corresponding costs of daylight accidents. That is, 46.1 percent of the night accidents were fatal compared to only 16.7 percent of the daylight accidents; 76.9 percent of the night accidents resulted in aircraft strikes as compared to only 38.9 percent of the daylight accidents. In terms of the phase of flight for the night accidents, the inflight and landing phases had equal incidence, followed by the "other" and takeoff phases in that order. For the daylight accidents, the greatest incidence occurred in the "other" phase followed by the landing, takeoff, and inflight phases.

Comparison of percent incidence of fatal accidents, aircraft strikes, and flight phases for the 18 orientation-error accidents that occurred under daylight visibility conditions (A) and the 26 accidents that occurred under night visibility conditions (B). Note the considerably greater hazard of the night flights.

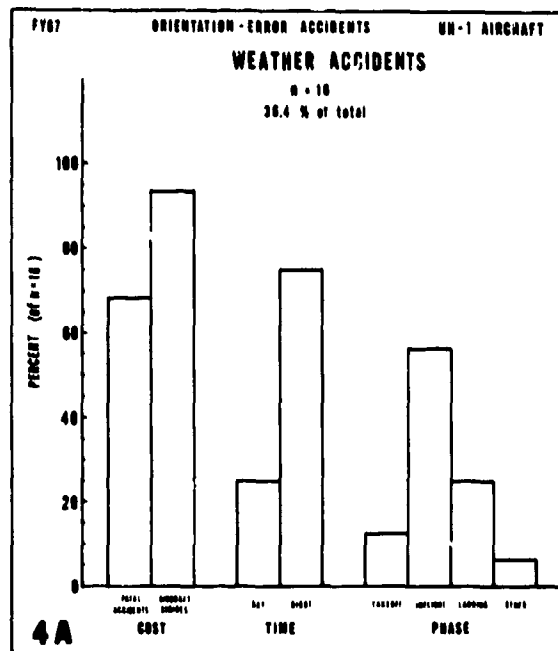
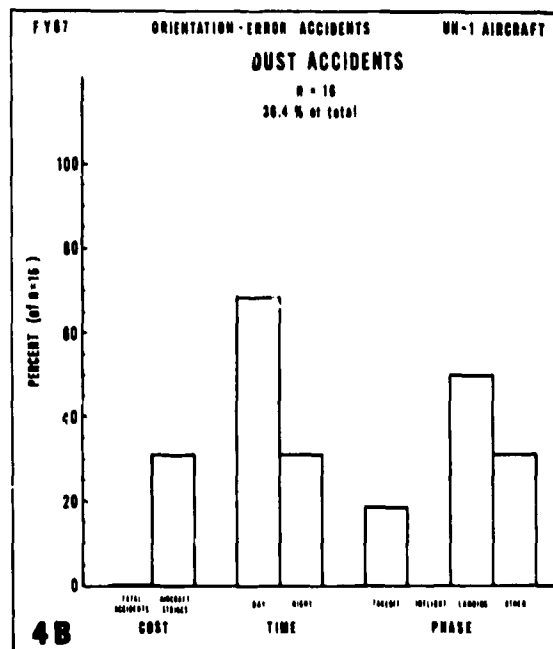
Figure 4

Data pertaining to accidents involving degraded visibility due to weather and rotor-raised ground dust are presented in Figure 4. As denoted in Figure 4A, poor weather of one form or another was present in 16 (36.4 percent) of the 44 major orientation-error accidents. The hazard of these weather accidents was most significant since 68.7 percent of the accidents were fatal and 93.7 percent resulted in aircraft strikes. The majority (75 percent) of these accidents occurred at night. In terms of the phase of flight when the accident occurred, the inflight phase had the highest incidence (56.25 percent). When these weather accidents involved flight at night, the incidence of fatal accidents rose to 75 percent. Of the four daylight accidents, two were fatal.

As indicated in Figure 4B, degraded visibility due to rotor-raised ground dust or ashes was present in an additional 16 accidents. Though no fatalities resulted from these dust accidents, a considerable number (31.2 percent) involved the total loss or strike of the aircraft. Relative to the phase of flight, landing accidents had the greatest incidence (50.0 percent); as will be gained from reading the individual case history briefs which follow, these occurred at established heliports as well as at temporary field sites. It appears from a cursory scan of the orientation-error accidents occurring in subsequent fiscal years of this study that application of penepreme or similar surface coverings to minimize dust has decreased the incidence of this form of accident.

Comparison of percent incidence of fatal accidents, aircraft strikes, day/night accidents, and phases of flight for the 16 orientation-error accidents that involved poor weather (A), and the 16 accidents that involved rotor-raised ground dust or ashes (B). Note the high incidence of fatal accidents and aircraft strikes involved in the weather accidents.

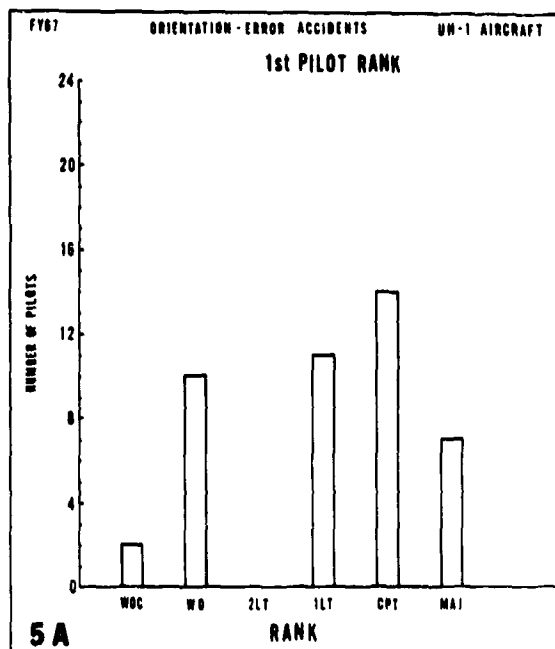
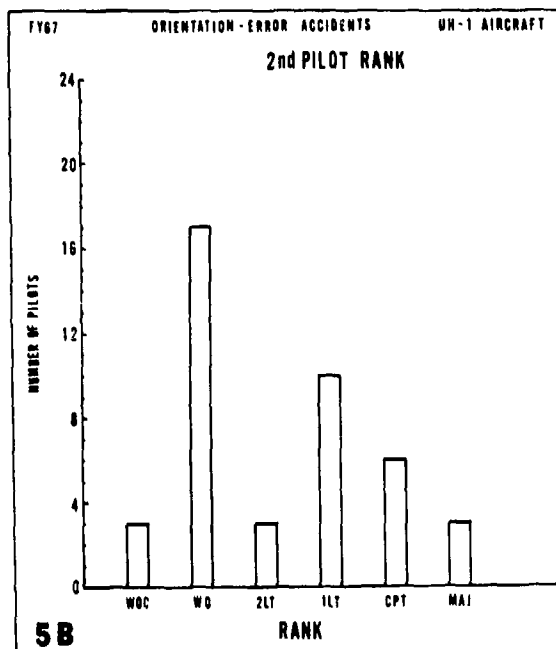
Figure 5

Distribution by rank of the 44 first pilots (A) and the 42 second pilots (B) involved in the orientation-error accidents. As explained in the text, the first pilot notation is used to describe the commanding aviator aboard the aircraft. In general, for Vietnam accidents, the first pilot is the "air commander" and the second pilot is the "pilot." For accidents occurring elsewhere, the first and second pilot notation usually corresponds to the conventional "pilot" and "copilot" designations, respectively.

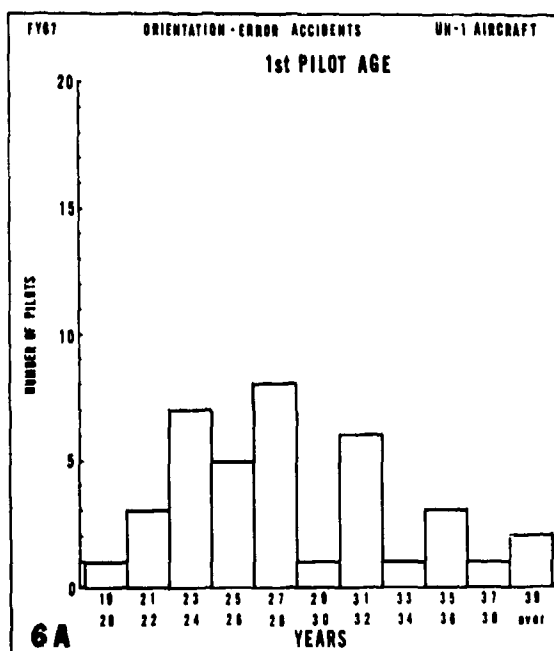
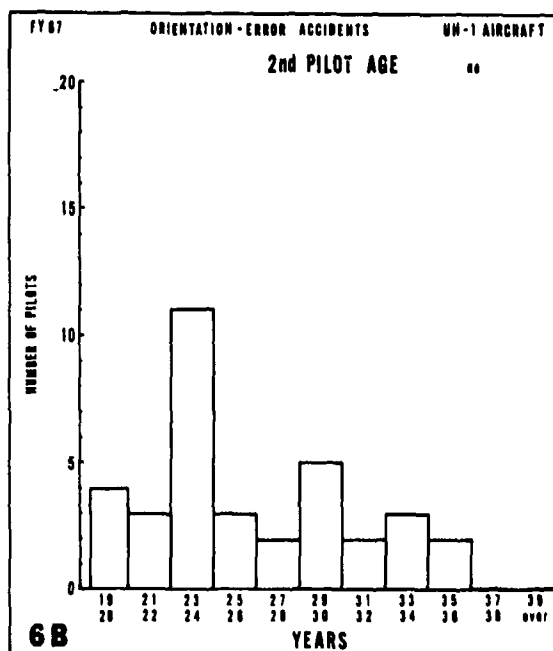
Figure 6

Age distribution of the first pilots (A) and second pilots (B). The median ages were approximately 27.8 years and 24.9 years, respectively.

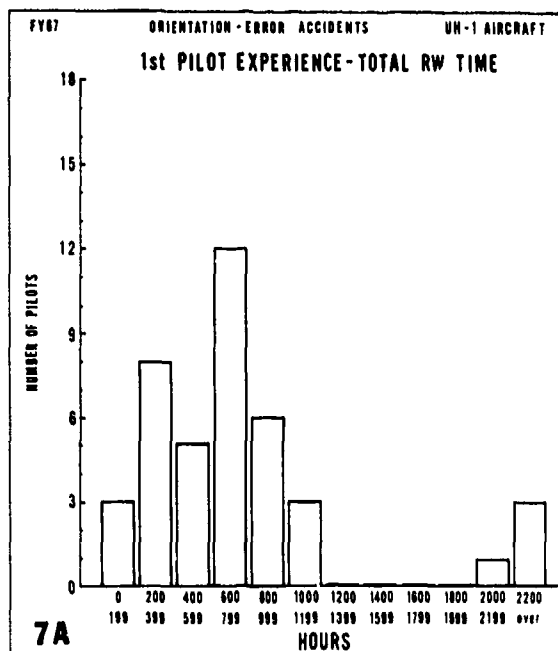
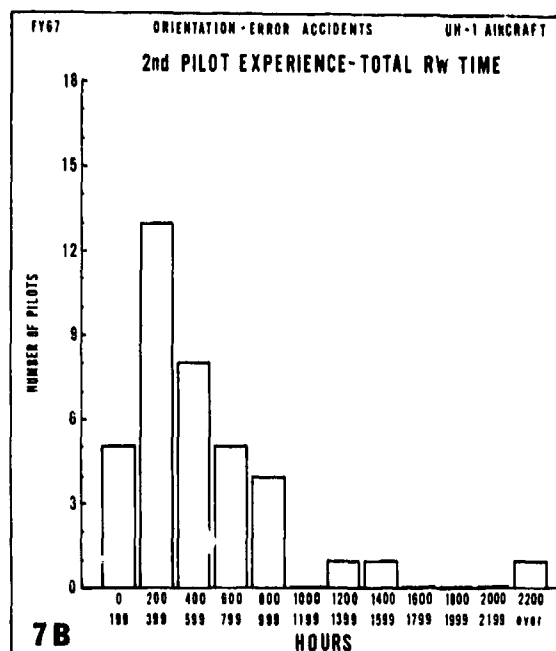
Figure 7

Distribution of total flight hours experience in military rotary-wing aircraft of the first pilots (A) and second pilots (B). The medians were approximately 675 hours and 425 hours, respectively. These data do not include any additional fixed-wing experience. (See Figure 10 for related FW and RW experience data.)

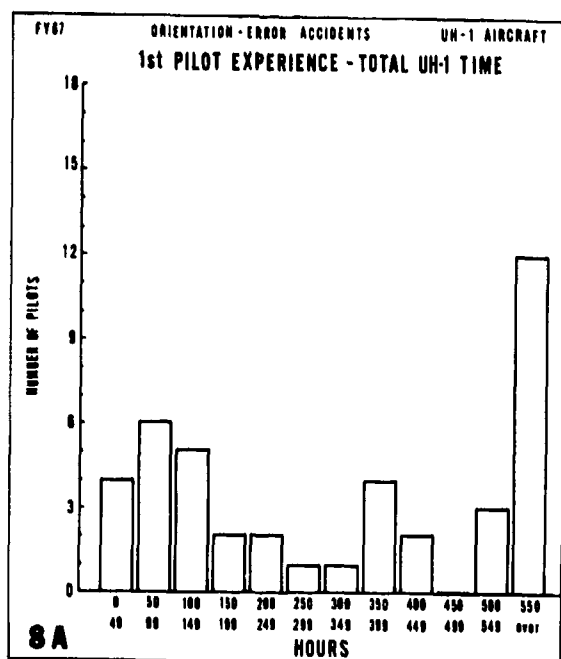
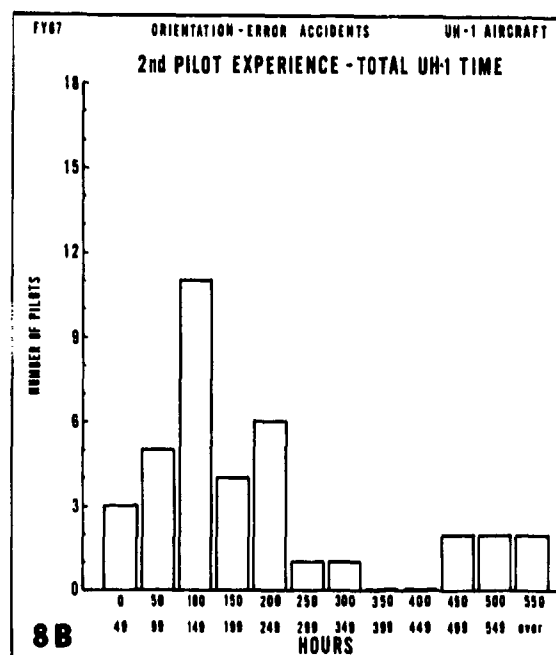
Figure 8

Distribution of total flight hours in the UH-1 aircraft of the first pilots (A) and second pilots (B). The median times were approximately 350 hours and 147.7 hours, respectively. (See Figure 10 for related UH-1 experience data.)

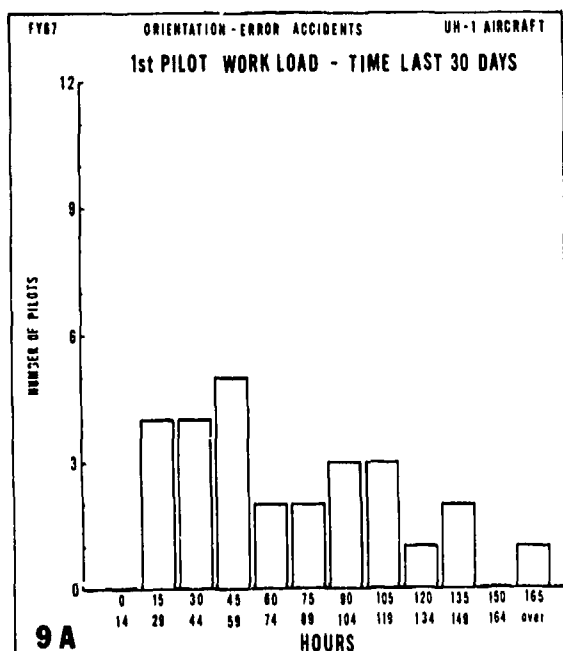
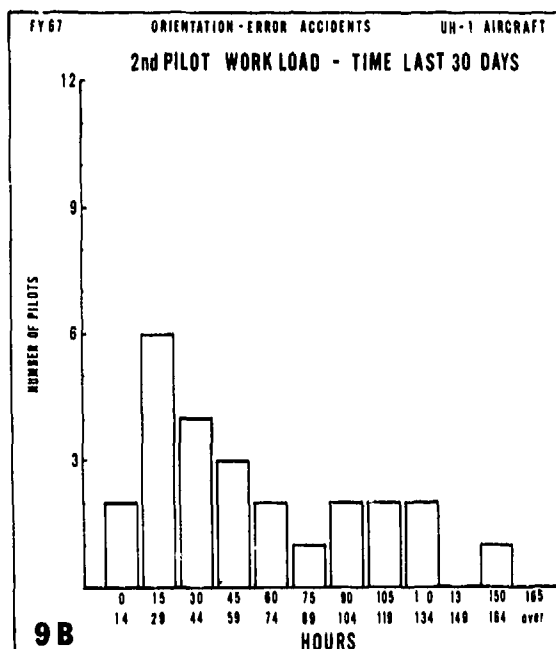
Figure 9

Distribution of pilot workload in terms of the total number of hours flown the 30 days preceding the accident by the first pilot (A) and the second pilot (B). The median workloads were 63.7 hours and 57.5 hours, respectively. (See Figure 11 for related fatigue listings.)

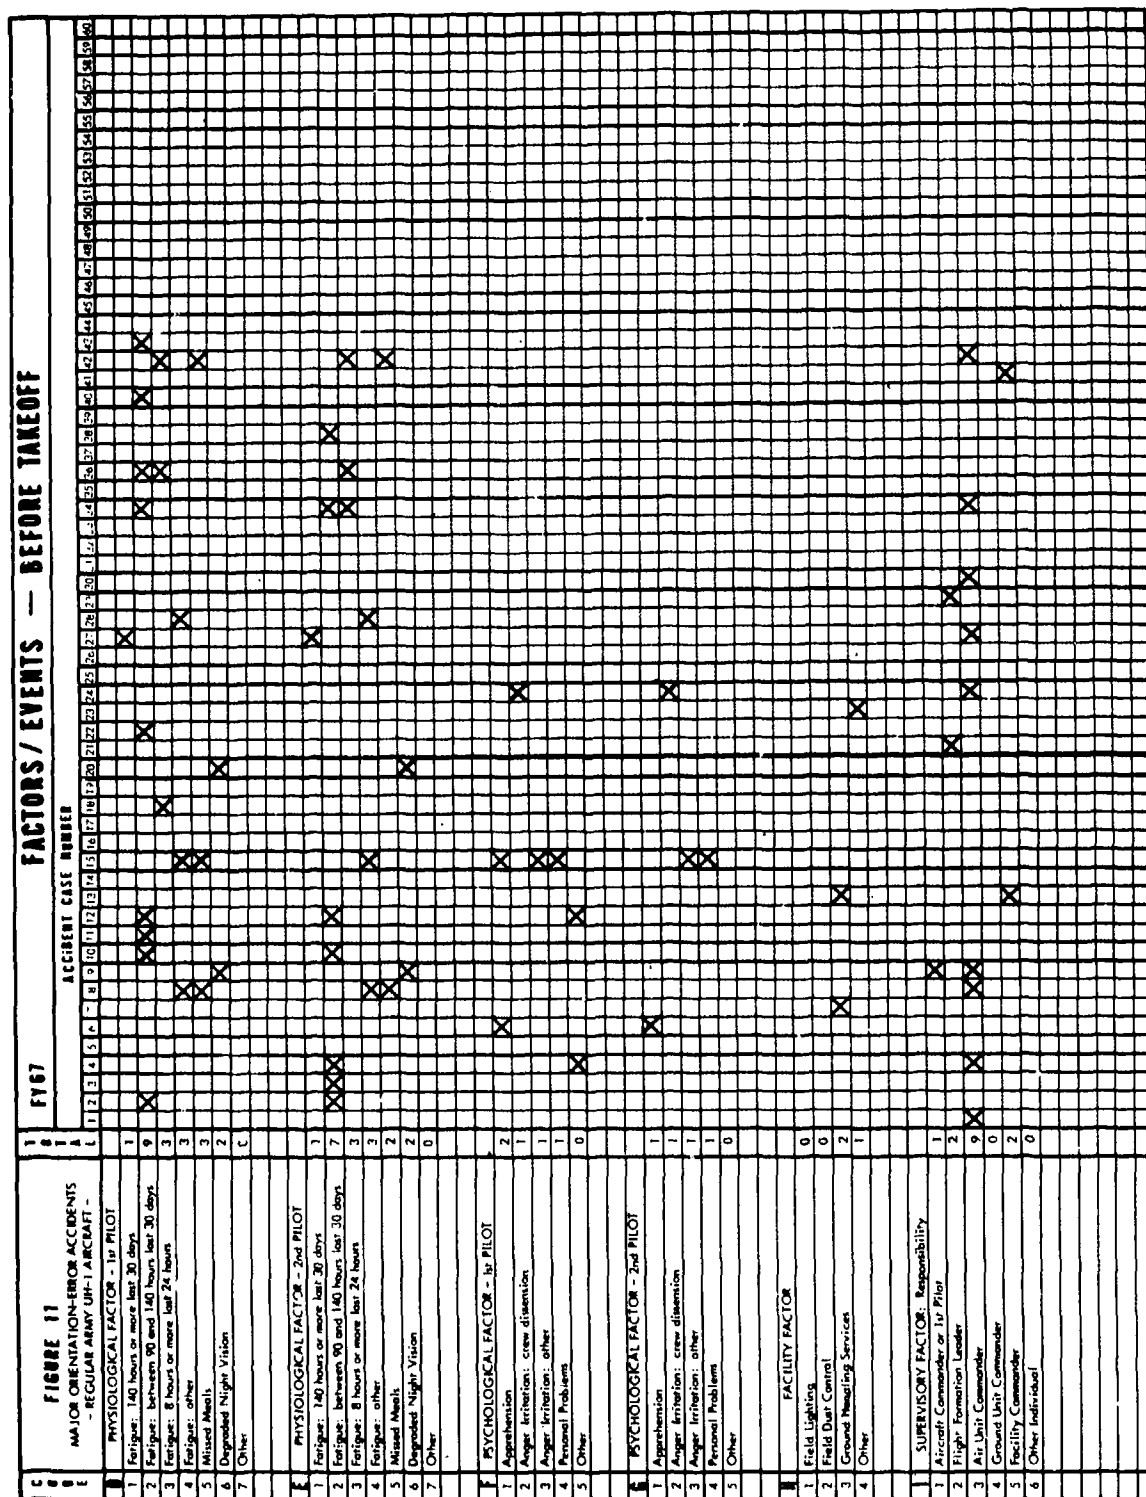
Figure 11

Individual case history listing of selected accident factors and events present before, or at the instant of, takeoff on the accident flight. See text for details.

Relative to physiological problems that existed prior to takeoff, fatigue was found to be the most obvious factor. Four entries, D1-D4 for the first pilot and F1-F4 for the second pilot, have been allotted to the description of this problem. Entries D1 and E1 denote aviators with greater than 140 total flight hours during the 30 days preceding the accident. Army regulations for Vietnam flight operations set this figure as the upper limit which cannot be exceeded except during tactical emergencies. Although it is possible to obtain permission at the battalion level to exceed this limit, the regulations direct the commanders to use the utmost discretion when granting this waiver. For that fiscal year there was only one flight, Case 67-27, in which both pilots had had more than 140 flight hours the previous 30 days. The same Army regulations also state that a crew member who accumulates 90 hours in a 30-day period will be closely monitored by the unit commander and the flight surgeon. This monitoring requirement is thus an implied recognition of individual susceptibility to fatigue. For this reason, the authors have chosen to also identify those accidents involving aviators with a workload greater than 90 hours, and less than 140 hours, the previous 30 days. The related D2 and F2 fatigue entries indicate 9 first pilots and 7 second pilots experienced this workload. In terms of both pilots, there were 13 (29.5 percent) accidents where either one or both of the aviators had flown more than 90 hours during the 30-day period preceding the accident.

Other entries listed under the physiological factor heading include D5 and E5, missed meals, and D6 and E6, degraded night vision. In D6 and E6, the entries show that some event or act occurred where it was highly probable that the night vision of the pilot was degraded. This is typified by Cases 67-9 and 67-20 where unshielded flashlights were used immediately before takeoff during the night preflight of the aircraft.

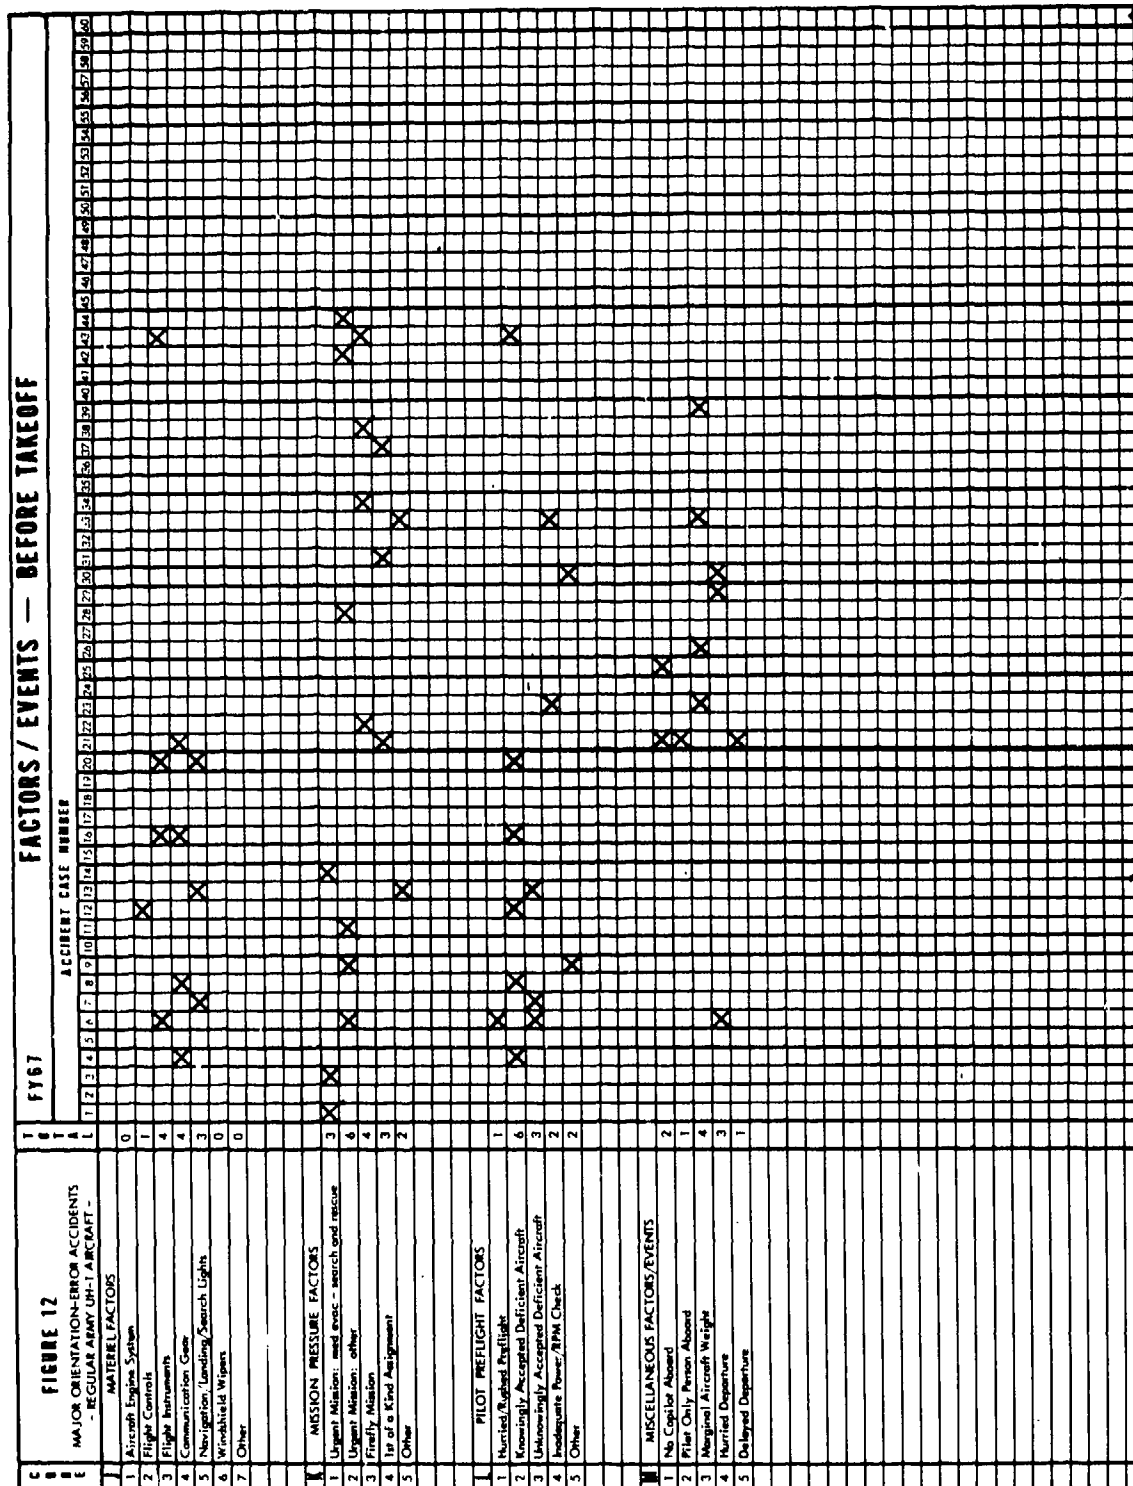
Figure 12

Continuation of the Figure 11 listing of before-takeoff factors and events.
